OBJET : 14 - Soutien du Centre socioculturel Al Bustan à Jérusalem Est - Autorisation de signature de la convention de partenariat entre la commune de Besançon et la commune de Gennevilliers

Juridical Analysis & Technical feasibility study for SILWAN Al Hayat (Al Bustan) foreseen center

Prepared by: PLACE Architects Lab

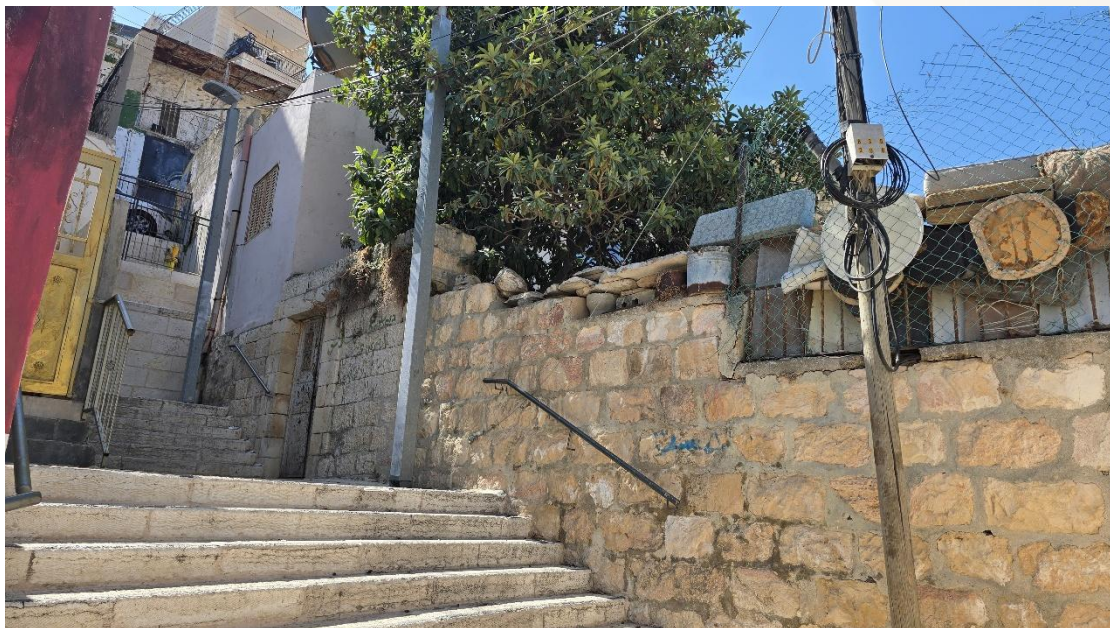
Figure: approach to the site and an overall caption of the building context

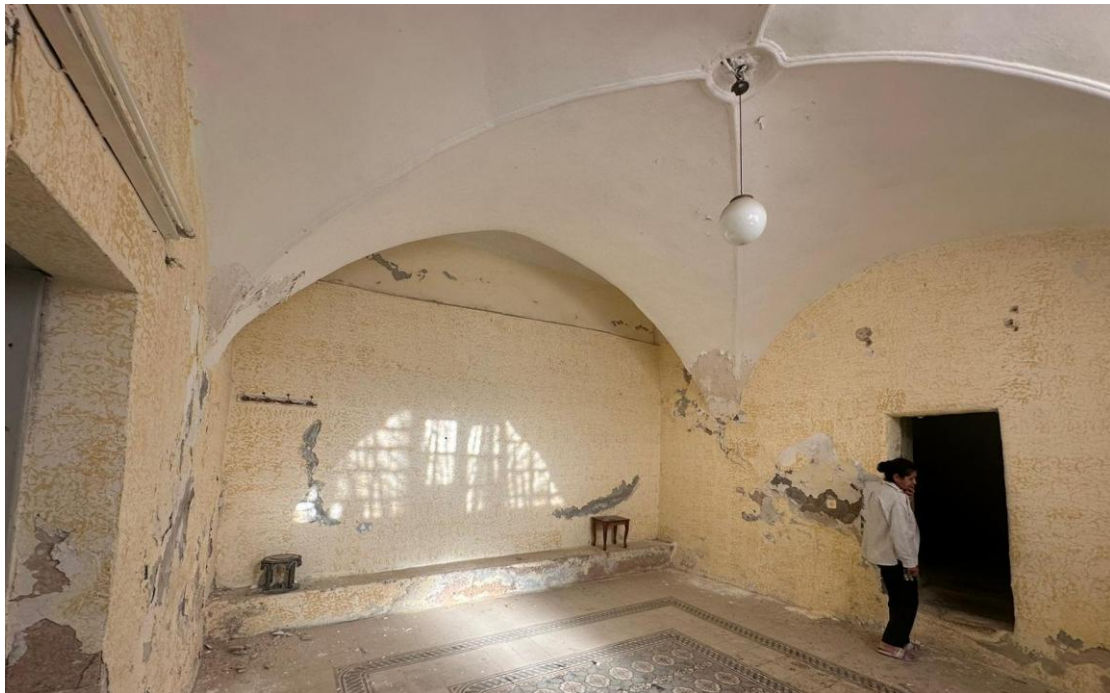
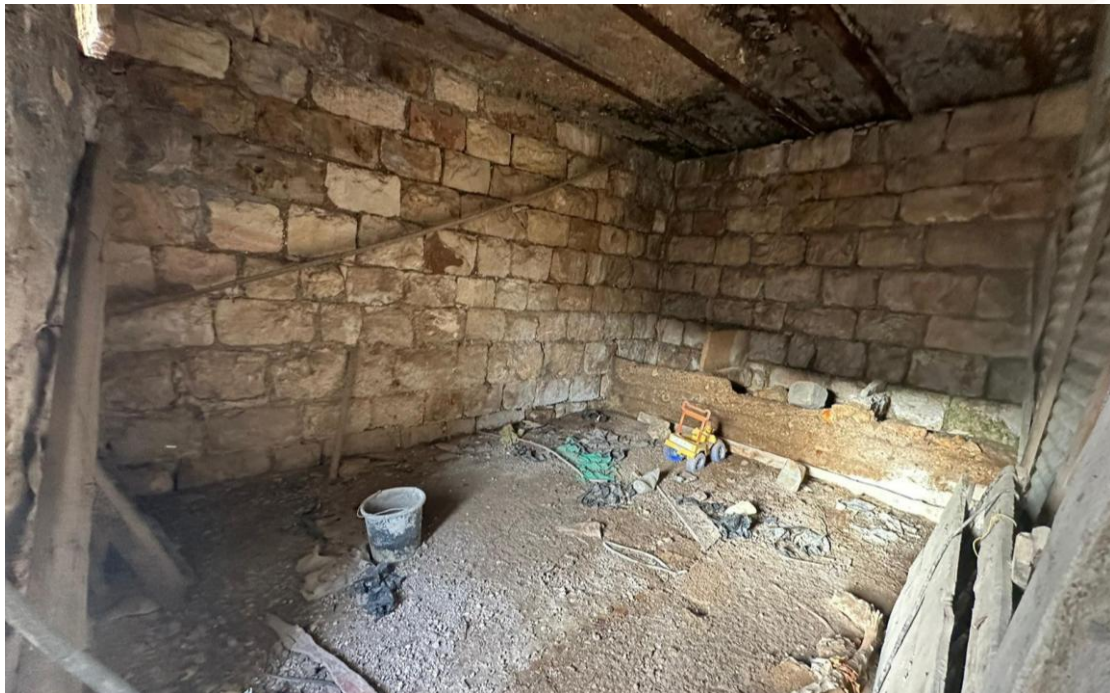
Figure 3 +4 : Architectural value of the interiors- ottoman era

The core architectural style and building characteristics date to the Ottoman period, though some parts of the complex or its foundations may likely originate from earlier eras, possibly as far back as the Crusader period. The surviving architectural features include cross vaults, arched windows, thick two-layered stone walls (approximately one meter wide), decorative niches, and traditional Palestinian patterned floor tiles, now sadly deteriorated due to neglect and humidity.

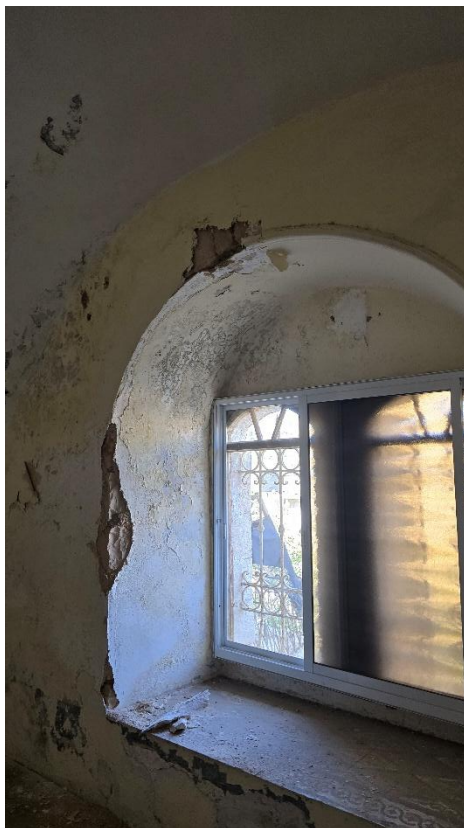
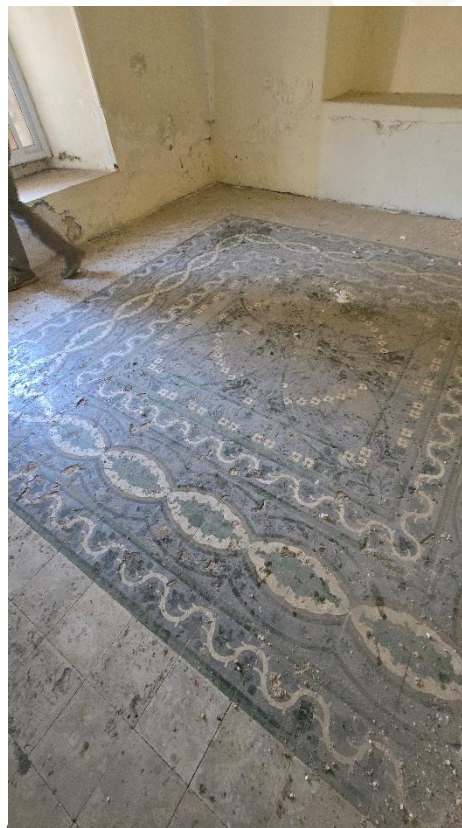
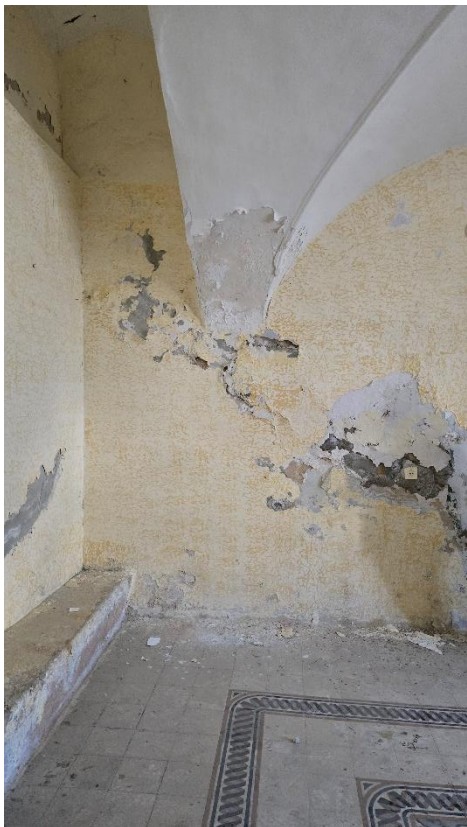
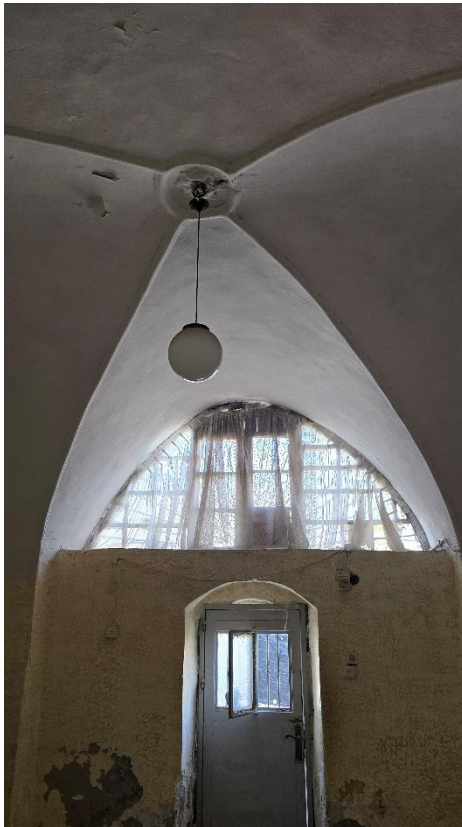
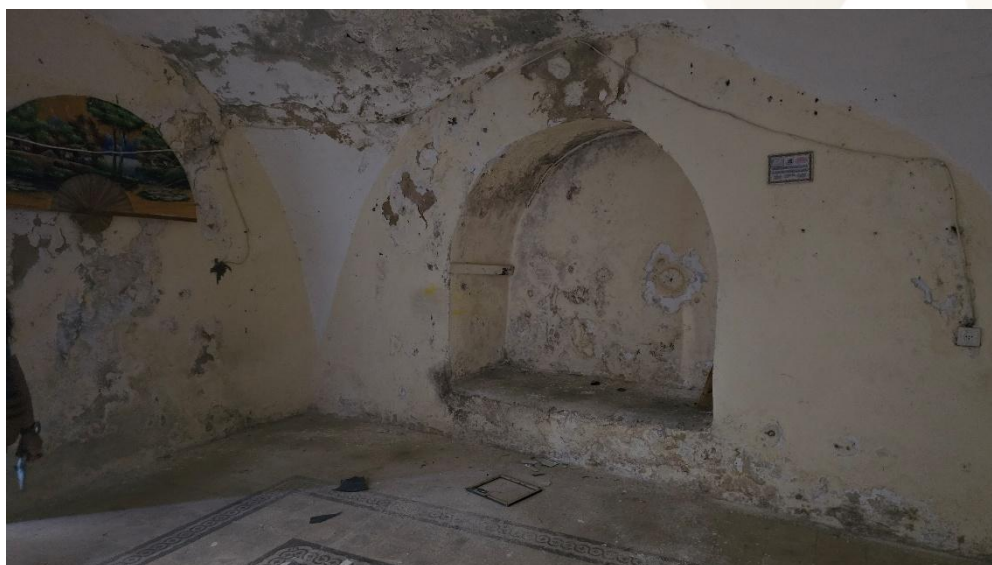
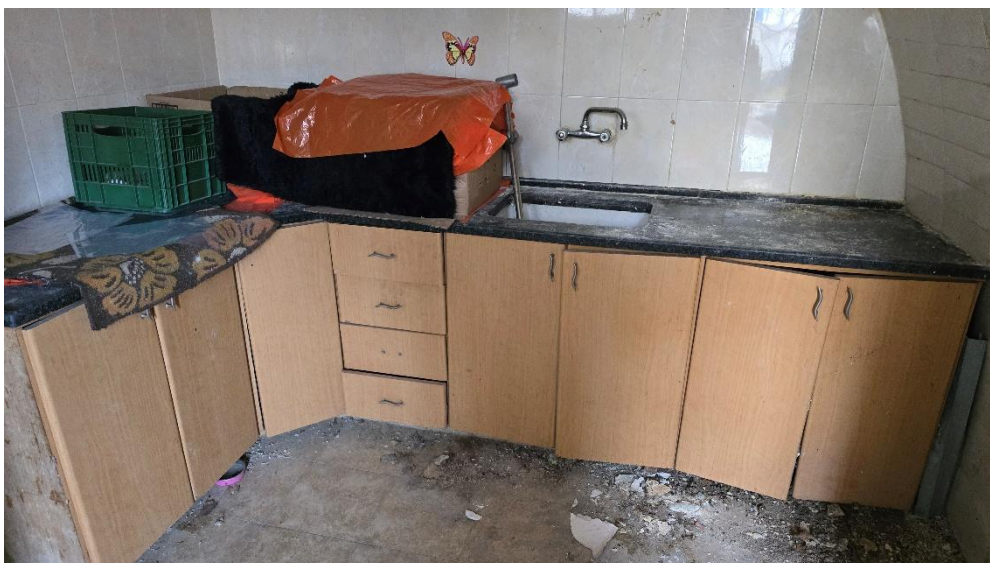
A- Main building (Rooms 1-4)

Below are pictures of the existing building and landscape status:

Based on our field assessment and visual inspection, the building is found in a **neglected and highly deteriorated state**. The floors are irregular, with remnants of old patterned cement tiles, though many are damaged and require either restoration or replacement. Wall plasters are failing in multiple areas, primarily due to prolonged moisture exposure and lack of maintenance. The joinery and external envelope are outdated and unsuitable for reuse, with aluminum and steel elements corroded or deformed beyond repair.

Room 4, currently housing two bathrooms and a kitchenette, is in particularly poor condition, with visible deterioration of finishes and evidence of malfunctioning drainage and mechanical systems. In the **cellars (1 and 2)**, the flooring and final leveling remain undefined; structural failures in these spaces require prior intervention before any finishing decisions can be taken. Electrical systems are
